# Manhole Inspection Summary

Manhole # S45II\_010MH

**Location** Address: **Gay St**

Cross Street: **Washington St**

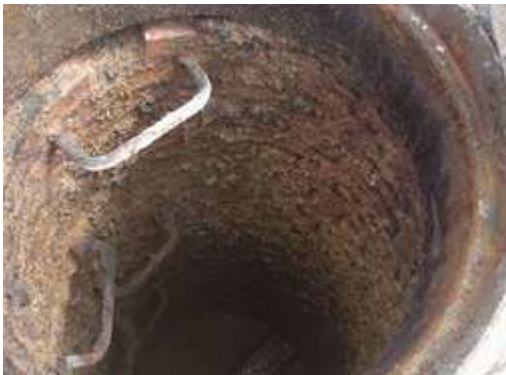
Defect 2

Condition: ☐ Sound ☐ Cracked ☐ Root Intrusion ☐ Loose Brick ☒ **Deteriorated**

Deterioration

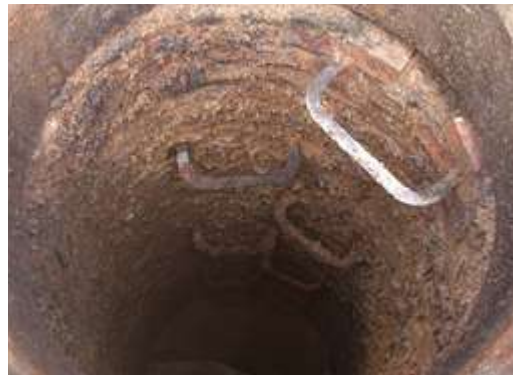
Defect 1

Infiltration: ☐ None ☐ Joint ☐ Cracks ☐ Mortar ☐ Roots ☒ **Wall**

Infiltration

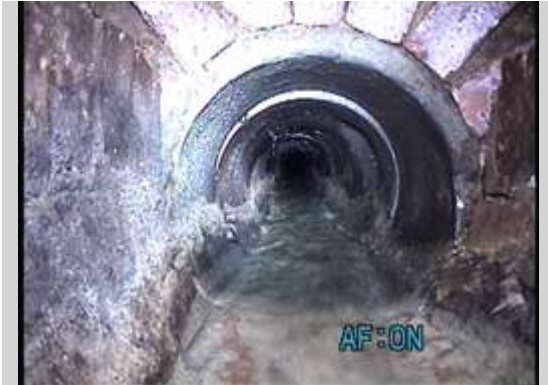
12 O'Clock Outflow

10 in. Circular Gravity Sewer  
Pipe Out @ 12 O'Clock

Pipe Height: **8.4** (in.) Rod and Bar (Angled)  
Pipe Material: **Clay** ☐ Pipe Lined  
Invert Depth: **13.20** (ft.) Flow Characteristics: **Fast**  
Deposits: ☒ None ☐ Mud ☐ Sludge ☐ Debris ☐ Grease  
Silt Depth: (in.) Deposits Extent:  
Infiltration: **None** Pipe Seal Cond: **Sound**

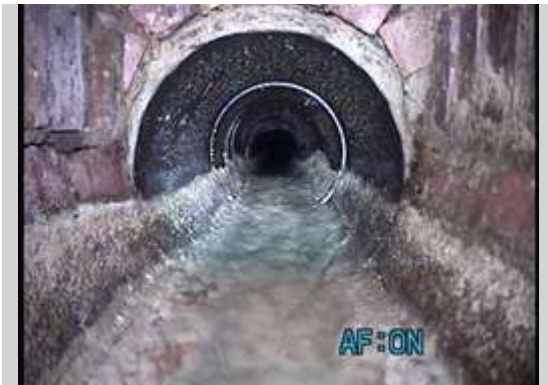
7 O'Clock Inflow

10 in. Circular Gravity Sewer  
Pipe In @ 7 O'Clock

Pipe Height: **8.4** (in.) Rod and Bar (Angled)  
Pipe Material: **Clay** ☐ Pipe Lined  
Invert Depth: **13.00** (ft.) Flow Characteristics: **Fast**  
Deposits: ☒ None ☐ Mud ☐ Sludge ☐ Debris ☐ Grease  
Silt Depth: (in.) Deposits Extent:  
Infiltration: **None** Pipe Seal Cond: **Sound**
